## **Tedlands and Boundary Wetlands Fish Passage Monitoring**

Jack McCann, Trent Power and Matt Moore April 2020

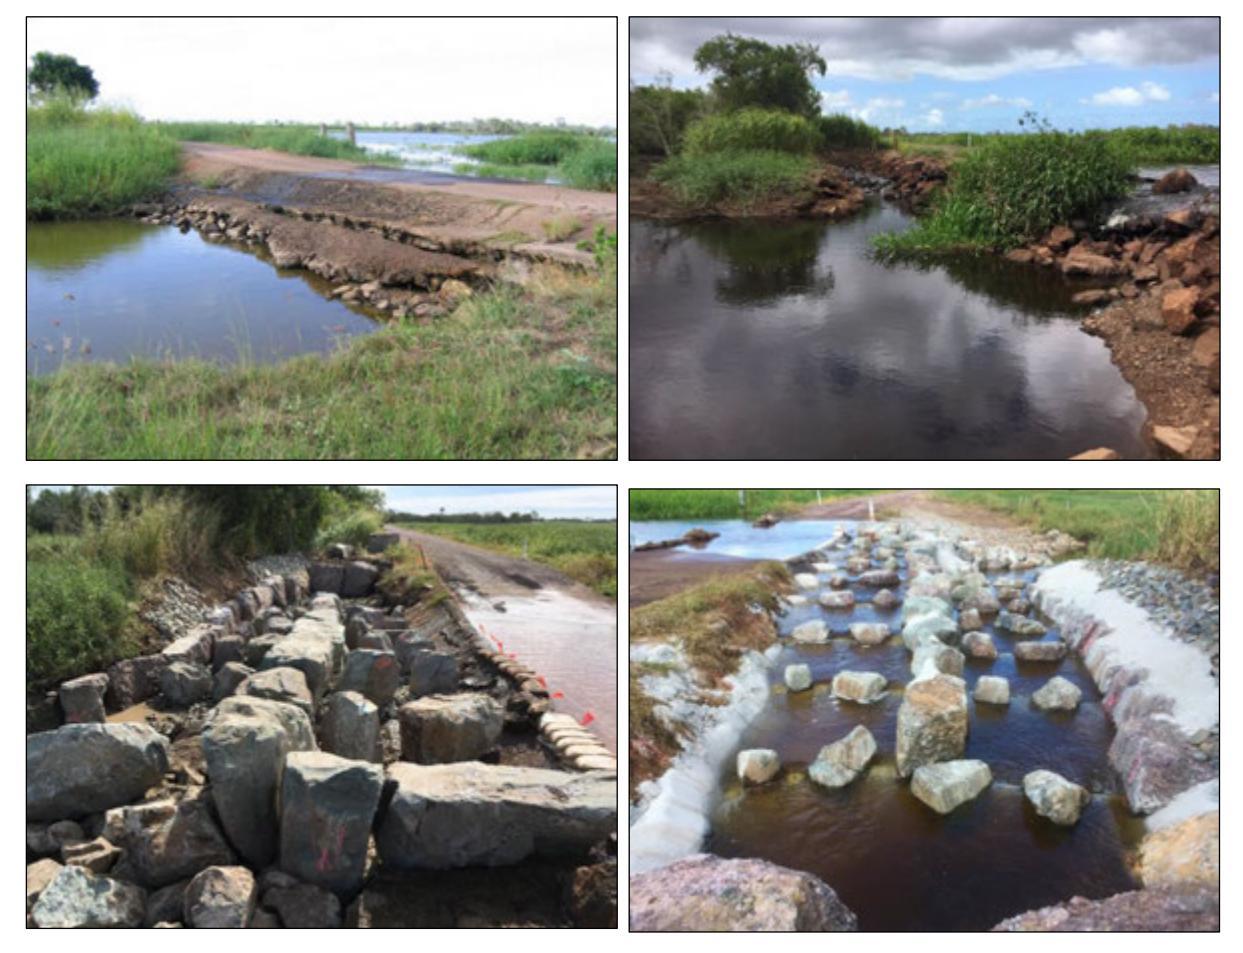
The Landing road causeway was a significant barrier to fish passage, bisecting upper tidal habitats of Rocky Dam creek and the extensive Tedlands wetlands complex. A rock-ramp was constructed at the site in 2008, however prolonged exposure to the marine environment significantly degraded the lower half of the structure. In 2019, funding was secured to repair the fishway. Larger rock and fibre-reinforced concrete was used to increase the functionality and longevity of the fishway (Figure 1). Innovative design features such as deeper resting pools (600mm) were also factored into the repair works. Ridge spacing is 2.0m, with 75mm drops between ridges. The width of the resting pools is 2.0m.

Figure 1. Landings Road causeway barrier (top left), original fishway prior to 2019 maintenance works (top right), fishway during repair works in 2019 where larger wall and ridge rocks replaced existing rock (bottom left) and image during first flow following repairs in 2019 (bottom right).

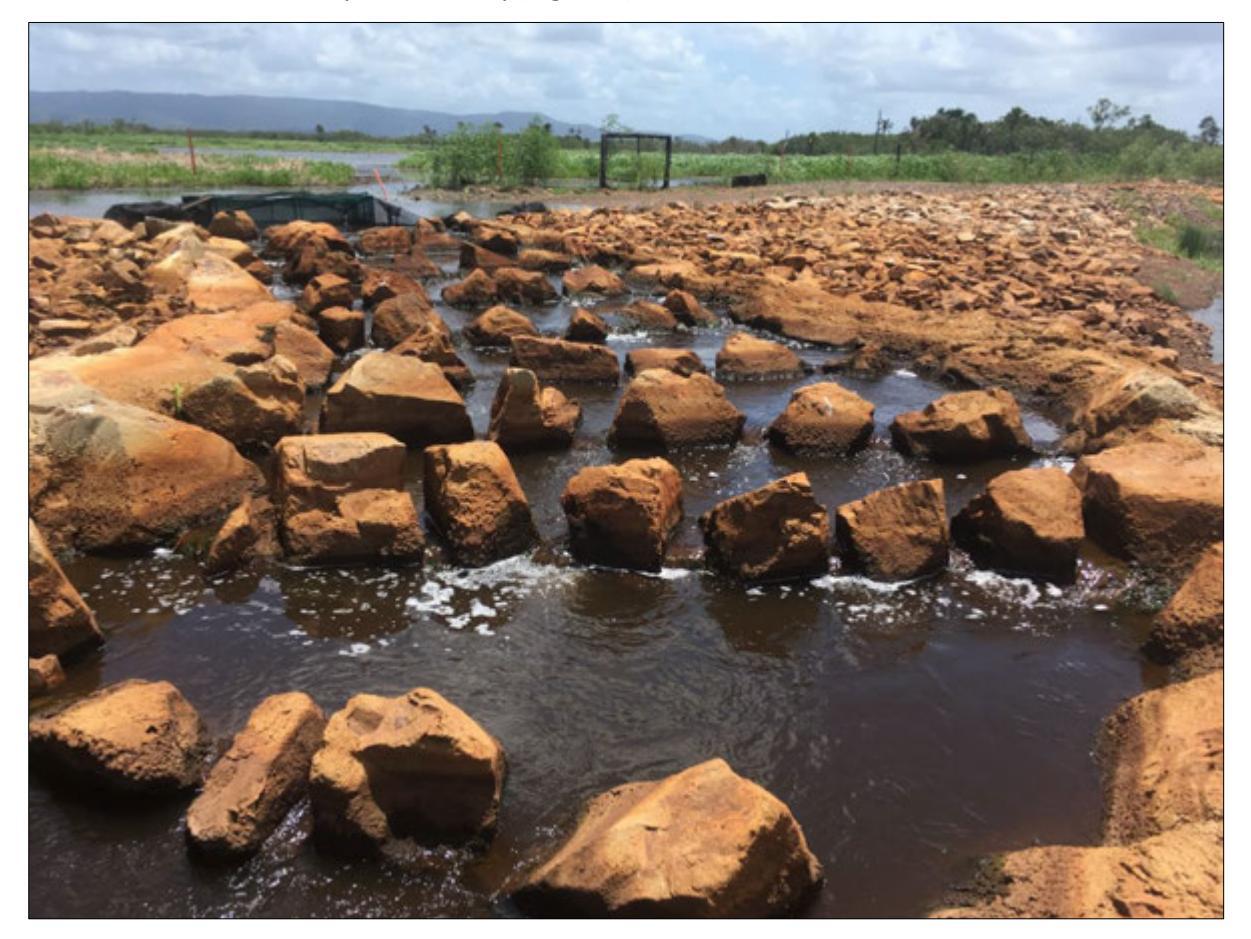
The Tedlands wetland eastern bund wall has also been fitted with a rock-ramp fishway. The fishway is a pool/ridge configuration. Pools are 4.0m wide, separated by 75mm drops over the ridges. Ridge spacing is 2.0m. The fishway was constructed in 2015 and provides additional connectivity between the wetlands and the Rocky Dam estuary (Figure 2).

Figure 2. Tedlands Wetland eastern bund wall rock-ramp fishway.

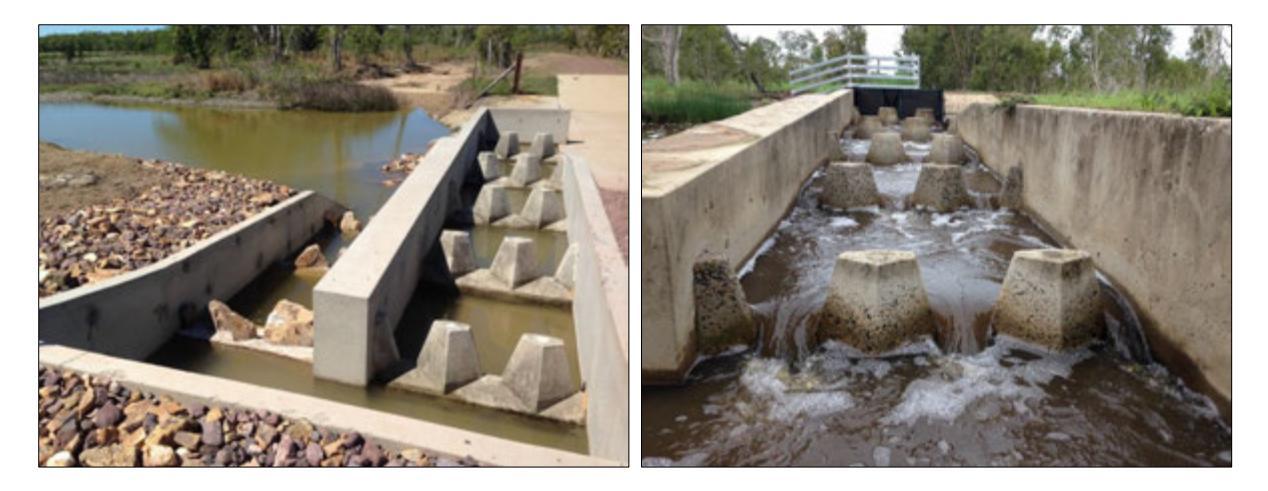
The cone-ramp fishway at the Boundary wetlands was constructed in November 2015 and was retrofitted to an existing causeway on the bund wall (Figure 3). This fishway is a pool/ridge configuration, which uses precast concrete as the ridge components. Ridge spacing in 1.5m, with 75mm drops between ridges. Pool width is 1.4m. The precision of concrete walls and ridges allows for a more compact design. This fishway provides connectivity between the wetlands and the Boundary Creek estuary.

Figure 3. Cone-ramp fishway following dry-season construction in late 2015 (left) and during fishway monitoring, with the fish trap visible at the top of the fishway (right).

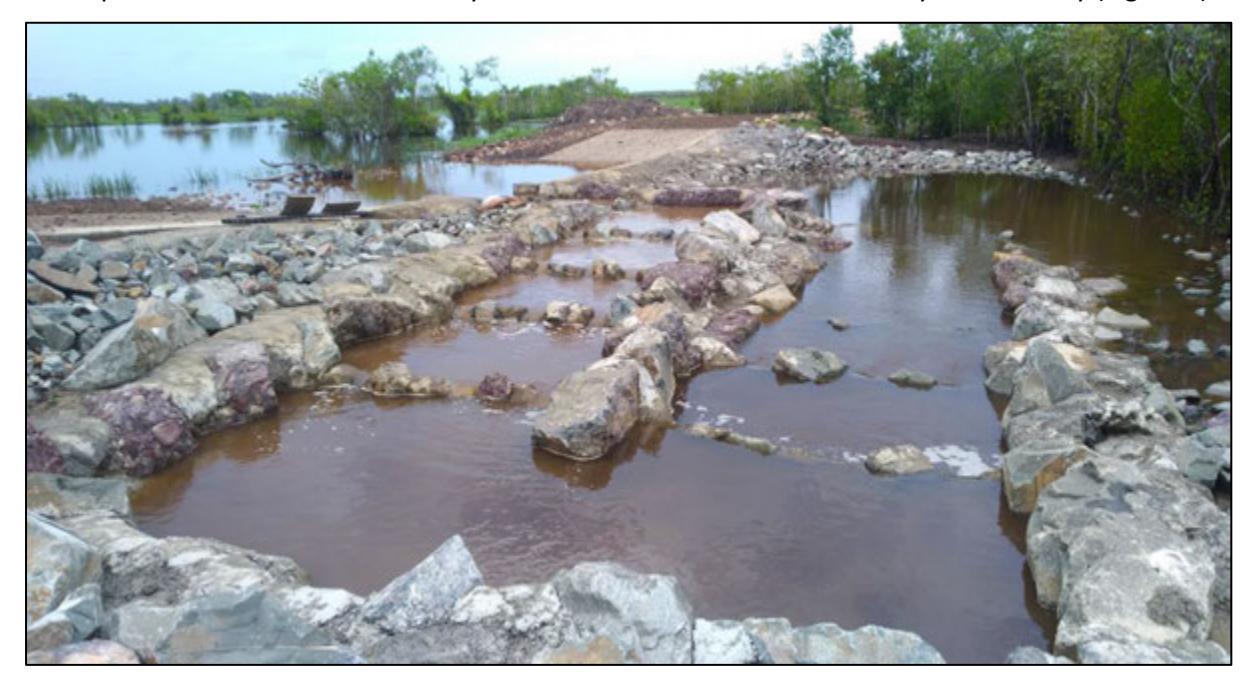
In 2019, a second causeway was constructed at the Boundary wetlands on the eastern bund wall. This was done to alleviate the pressure on the bund walls during high flows in the wet-season, and reduce the risk of the bund walls being overtopped and damaged. The rock-ramp is a pool/ridge configuration with 2m ridge spacing and 75mm ridge drops. Pool widths are 2m and depth of the pools is 600mm which provides additional connectivity between the wetlands and the Rocky Dam estuary (Figure 4).

Figure 4. Boundary wetlands rock-ramp fishway and causeway following construction in the 2019 dry season. The freshwater wetlands are visible to the left of the image, upper tidal reaches visible on the right.

While restricted access prevented sampling of the new rock-ramp fishway, it is expected that the new fishway will provide high levels of connectivity between the wetland and the estuary, based on monitoring of other fishways in the region with the same design features and on similar barrier types.

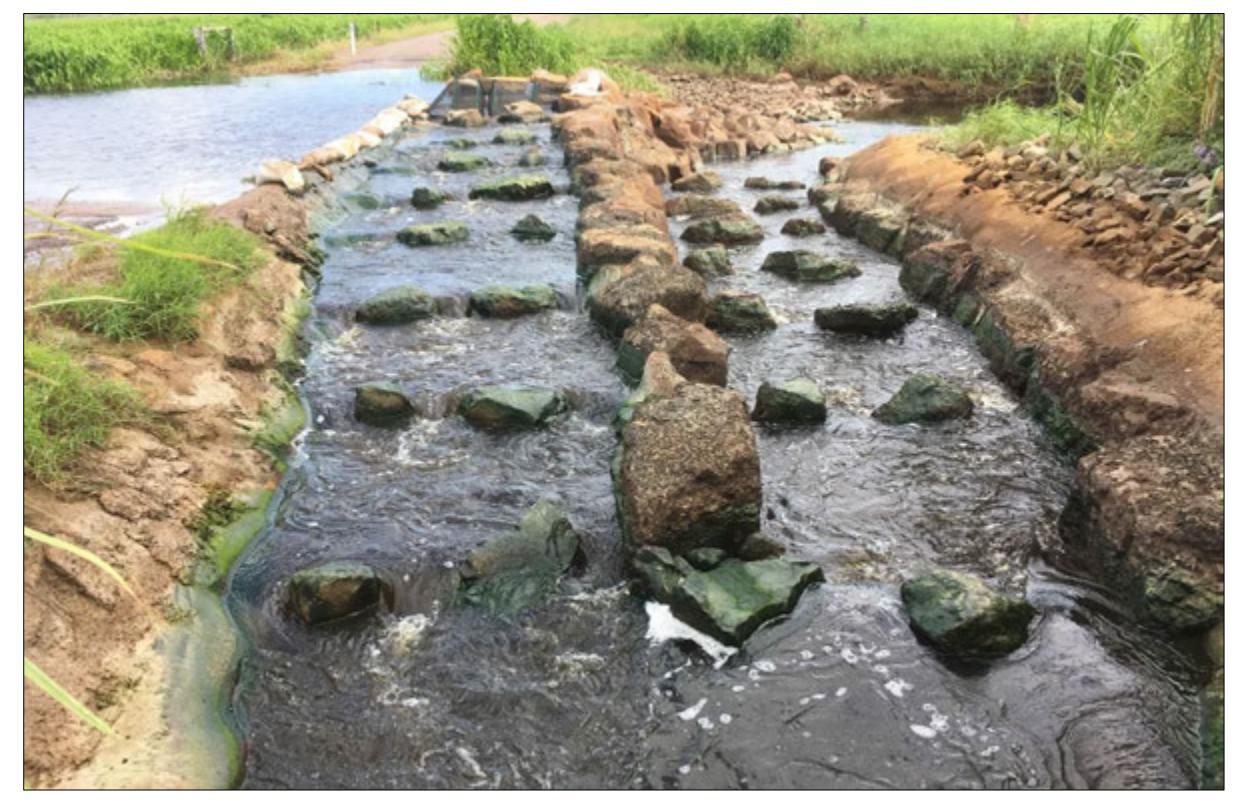
The monitoring at both the Landing Road rock-ramp and Boundary cone-ramp used the same trap configuration. These traps consisted of a single cone entrance, 120mm wide x 600mm high. The trap frames were constructed from 10mm stainless steel round bar and measured 1.4m x 1.0m 1.1m. Shade cloth (2.0mm mesh size) covered the trap frames. Where necessary, shade cloth wing walls were used to prevent fish from swimming around and under the traps. The traps and wing walls were secured using sand bags.

All fishway traps were positioned at the top of the fishway to ensure all fish captured had ascended the entire fishway. At each site, multiple trap checks were made each day and left in place each night to continue sampling.

Figure 5. Landing Road fishway at Tedlands wetlands during the monitoring, with fishway trap visible in the final cell of the fishway, catching all fish ascending the fishway.

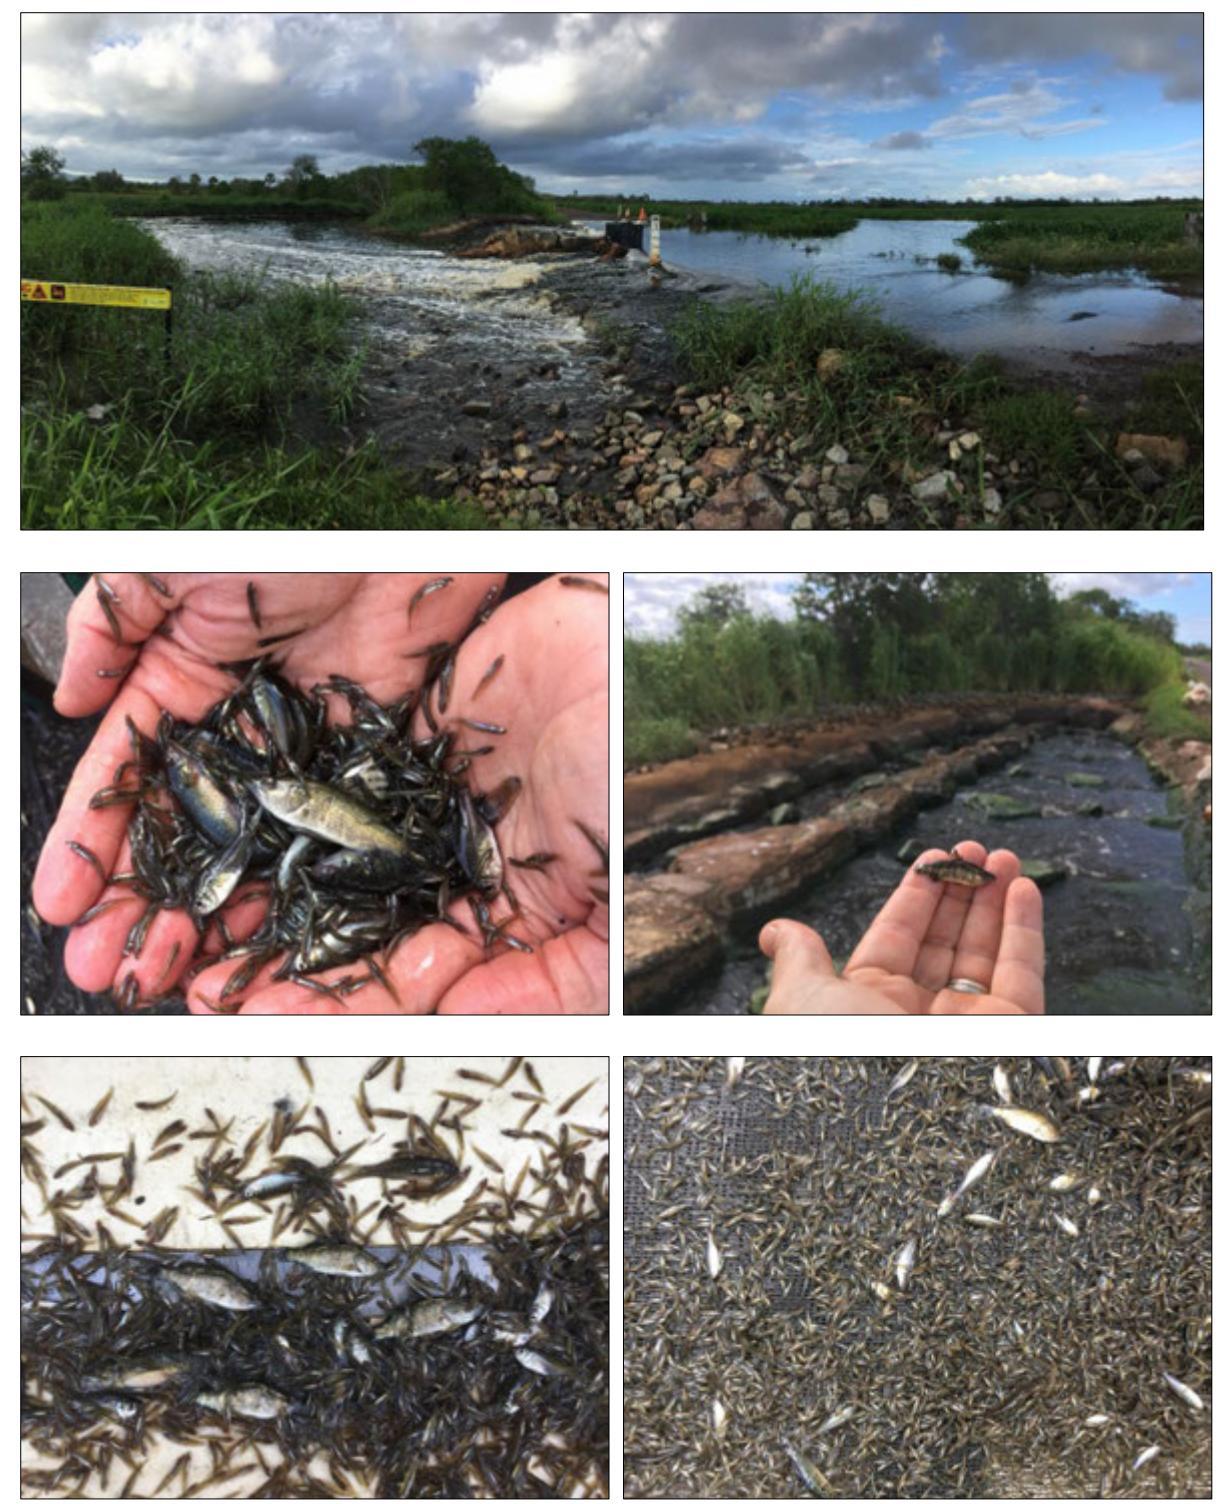
Figure 6. Top to bottom, left to right, 1) panoramic image of Landing Road fishway in flow during monitoring, 2) close up image of empire gudgeon (*H. compressa*), Agassizi's glassfish (*A. agassizii*) eastern rainbowfish (*M. splendida*) and barramundi (*L. calcarifer*), 3) young-of-year barramundi recruit with fishway in the background, 4) and 5) typical mixed species trap haul, comprised primarily of high numbers of juvenile empire gudgeon.

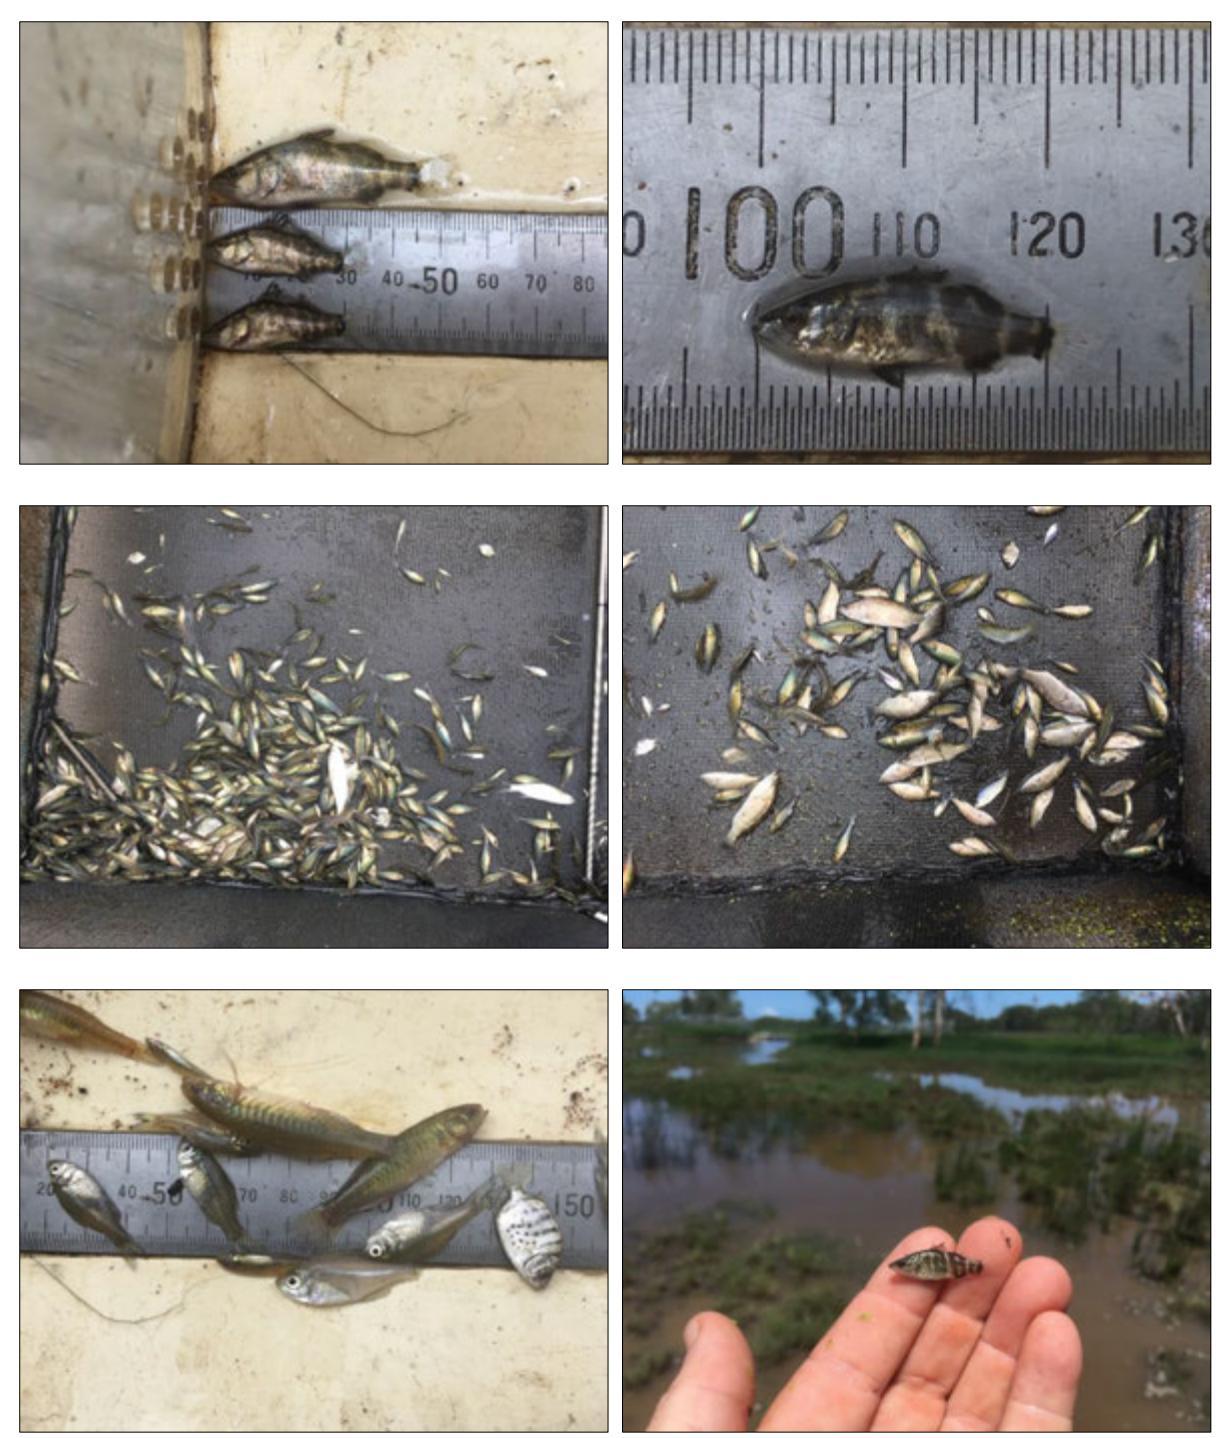
Figure 7. Top left to bottom right, 1) Juvenile barramundi (*L. calcarifer*), 2) smallest barramundi captured ascending the cone-ramp at 25mm, 3) typical mixed species trap haul, 4) single trap haul consisting of 49 juvenile barramundi recruits amongst other species, 5) close up image of empire gudgeon (*H. compressa*), Agassizi's glassfish (*A. agassizii*) and banded scat (*S. multifasciata*), and 6) juvenile barramundi showing supralittoral post-larval habitat in the background.

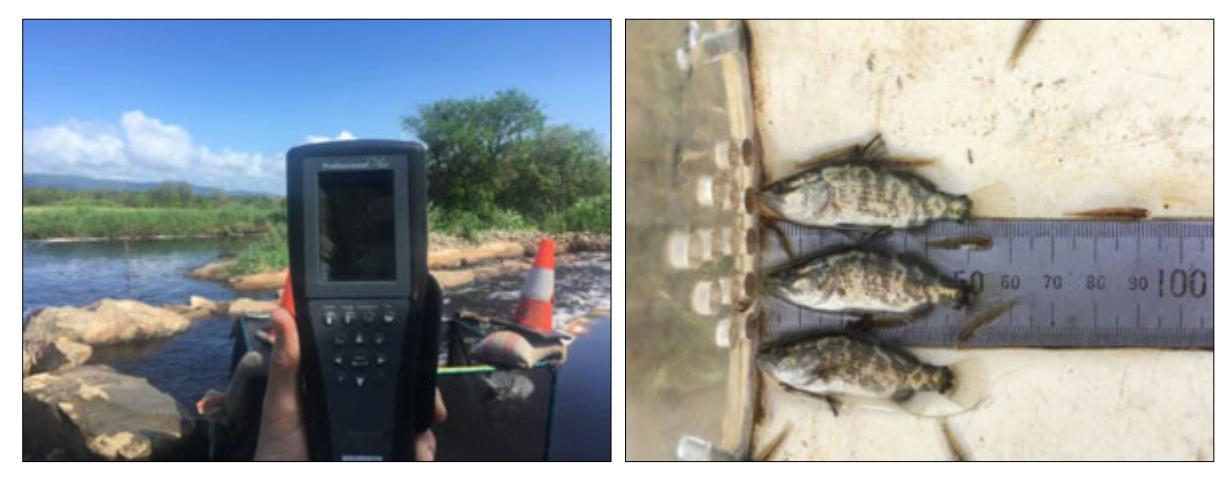
During the first overnight monitoring period across February 10<sup>th</sup> and 11<sup>th</sup>, overall catch rates and species diversity were discernibly lower than recorded at the Boundary wetlands cone-ramp for the same period. This was attributed to the poor quality of water (low dissolved oxygen saturation) discharging from the wetlands during these early wet-season flows. This is evident in the upstream dissolved oxygen reading taken at the commencement of the first trap set period on February 10<sup>th</sup> at 5:00PM, where dissolved oxygen was recorded at 3.6% saturation. This is considered hypoxic and is below tolerance levels for fish communities within the wetlands. These results were consistent with previous years monitoring of the two wetlands.

Figure 8. Left; water quality meter showing dissolved oxygen reading of 5.25% during February monitoring, and right; juvenile barramundi (L. calcarifer) monitored ascending the fishway when dissolved oxygen levels in the wetlands returned to tolerable levels in March.

Catch rates and species diversity increased considerably during the second round between March 18<sup>th</sup> and 20<sup>th</sup>, which coincided with improved dissolved oxygen levels during the daytime sets. Notably, the dissolved oxygen levels fluctuated considerably throughout the day, dropping below tolerable limits of many species during the evening. This was reflected in poorer catches in the overnight trap sets, and through the dissolved oxygen readings taken upon arriving at the site each morning. Morning DO readings upstream of the fishway were 10.9%, 8.01% and 4.9% for each of the consecutive three days (Table 1).

The reduction of DO to hypoxic conditions overnight is of concern. There is the possibility under particular weather conditions (e.g. still, overcast days) that oxygen levels may fall below tolerance limits for extended periods (6h<sup>+</sup>) and cause fish kills. The low DO levels in Tedlands have been attributed to the overgrowth of the invasive weed *Hymenachnae ampiplexis* (Hymenachnae). It is recommended that Hymenachne control continues to increase and maintain the amount of open water. It is also recommended that more in depth investigations into ambient water quality conditions throughout the wetlands be undertaken, especially of dissolved oxygen.

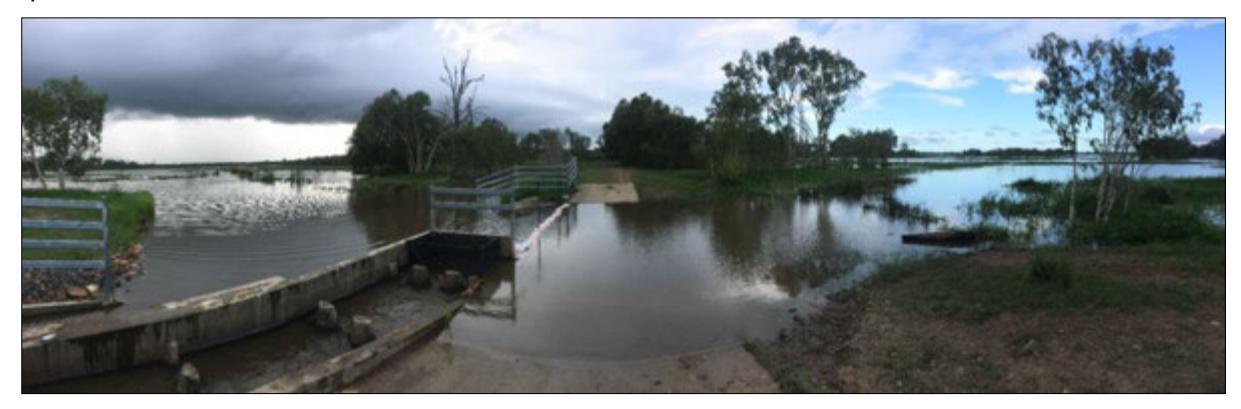
Monitoring results at the Boundary wetlands cone-ramp fishway were relatively consistent in terms with previous years and to other similar interface barriers in the region. This indicates good connectivity is provided by the fishway.

Figure 9. Panoramic image showing the fishway in the left foreground, which boosts the regions fisheries resources through allowing aquatic connectivity between the Boundary Creek estuary (left of image) to the extensive Boundary wetlands (right of image). The image is taken from the concrete causeway, which creates the barrier between the two water bodies.
